Issued: June 10, 2019

2C5382: Why Hastings uses Flex-vent instead of OEM design

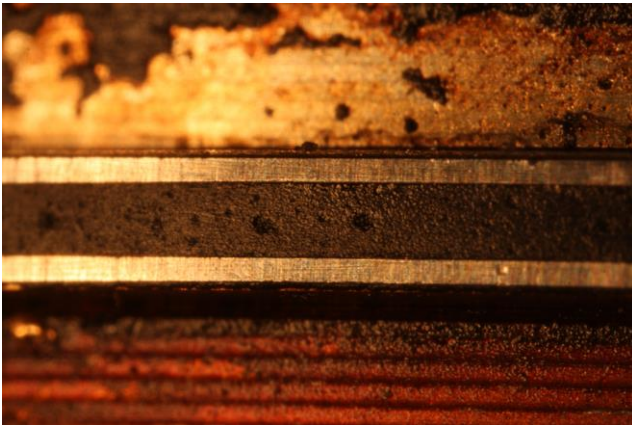
OEM 2pc Ring – Oil Drain Holes Clogged

Below on the left is a picture of the OEM 2pc oil control ring with the clogged up holes and the right picture after the ring was cleaned. The Hastings Flex Vent design shown at the bottom provides more area for oil to drain back which eliminates the possibility of clogging. Other added benefits of the Flex Vent oil assembly for gasoline engines include excellent conformability to the cylinder walls, improved efficiency and high resistance to installation breakage compared to the OEM 2pc oil control ring.

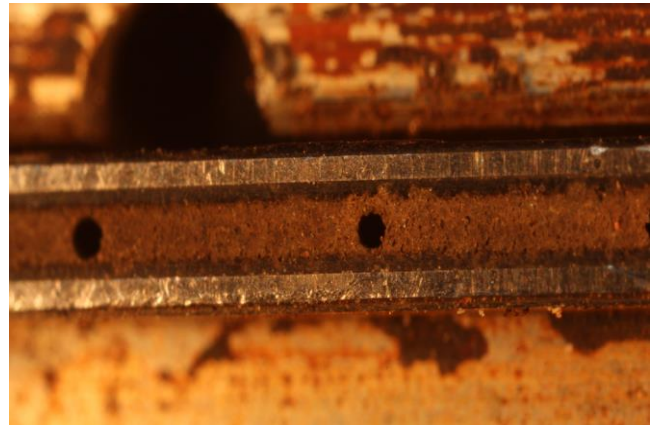
OEM 2pc Ring – Oil Drain Holes Cleaned

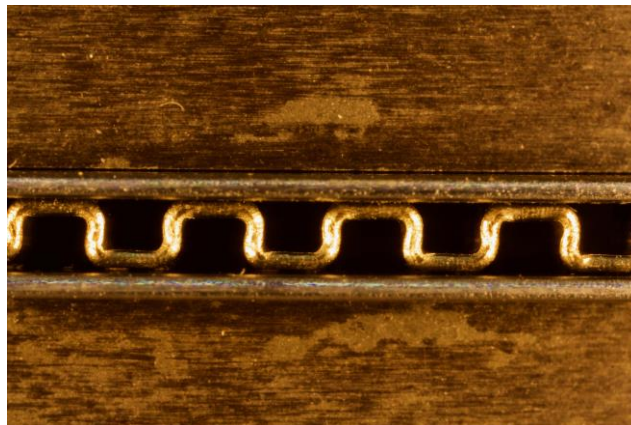
Hastings Flex Vent – Large Oil Drain Back Area
